X-481-69-37 PREPRINT

TOS EVALUATION CENTER (TEC) POSTOPERATIONAL TEST RESULTS FOR ESSA 4

Robert R. Golden
Goddard Space Flight Center
and
Duane A. Kaeding and David E. Briggs
RCA Service Company

January 1969

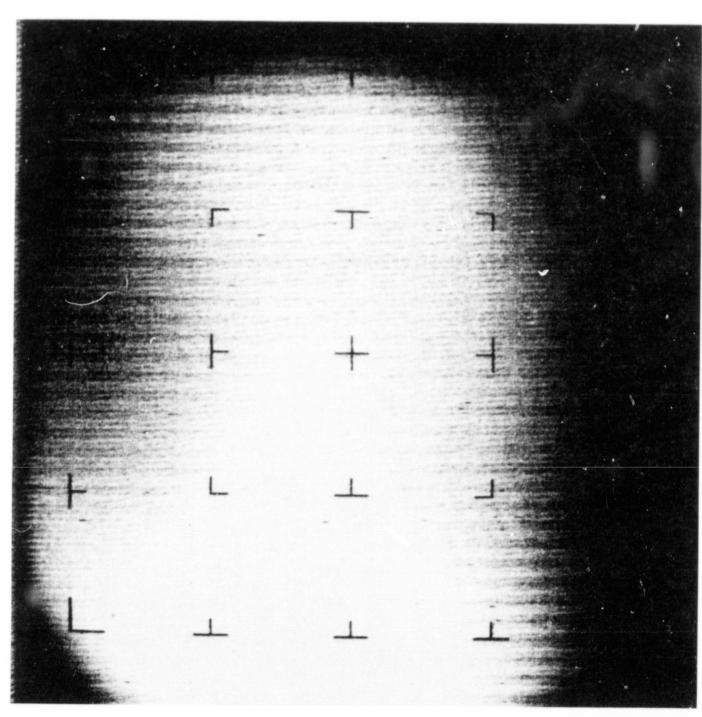
Figure 3. Spacecraft in Sun, Camera 1

- 2) The true "black level" of a black earth is so close to that of the fiducial marks that it is difficult to pick out the difference in either the facsimile picture or on A-scans. The black level of the fiducials is a valid criterion of what the actual black level of the picture would be if in fact the spacecraft were seeing a black subject in its picture area. This is very useful to TEC, as the black level in an A-scan through the center fiducial is used as a criterion for the performance quality of the camera. The reticle, as the only black available in the working area of a normal picture, is a standard for monitoring the degradation of an APT**camera (Figures 3 and 4).

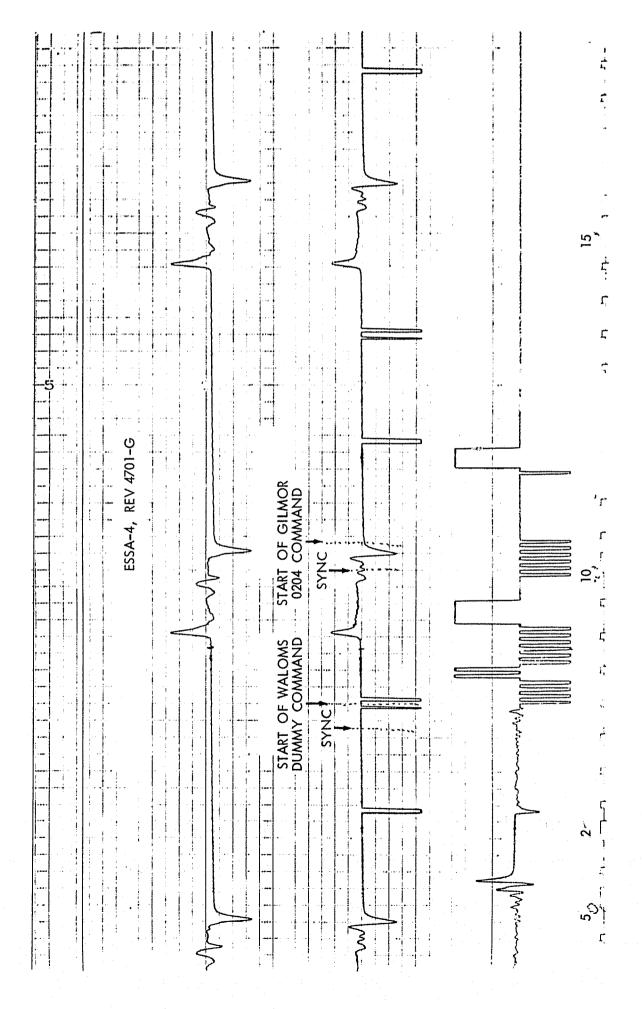
- C. Results: On February 1, 1968, during revolution 4701, both the Wallops and Gilmore CDA stations commanded the spacecraft at the same time. Both CDA's used command tone-pair A and transmitted digital commands. Figures 5 and 6 are samples of the responses. Some narrow "0" bits and some narrow sync bits were received as indicated in Figure 5. Once an extra "1" bit was obtained in an address; Figure 6 shows the readout of this incident. The spacecraft accepted no invalid commands when both CDA stations were transmitting, although an address or command could be made invalid and consequently rejected by the spacecraft. However, a remote word might possibly be altered by "jamming" and still be accepted by the spacecraft, because the 2-out-of-12 parity check does not apply to the remote word; however, CDA error sensing normally prevents transmission of an invalid remote word.

Figure 5. Simultaneous Commands to Spacecraft

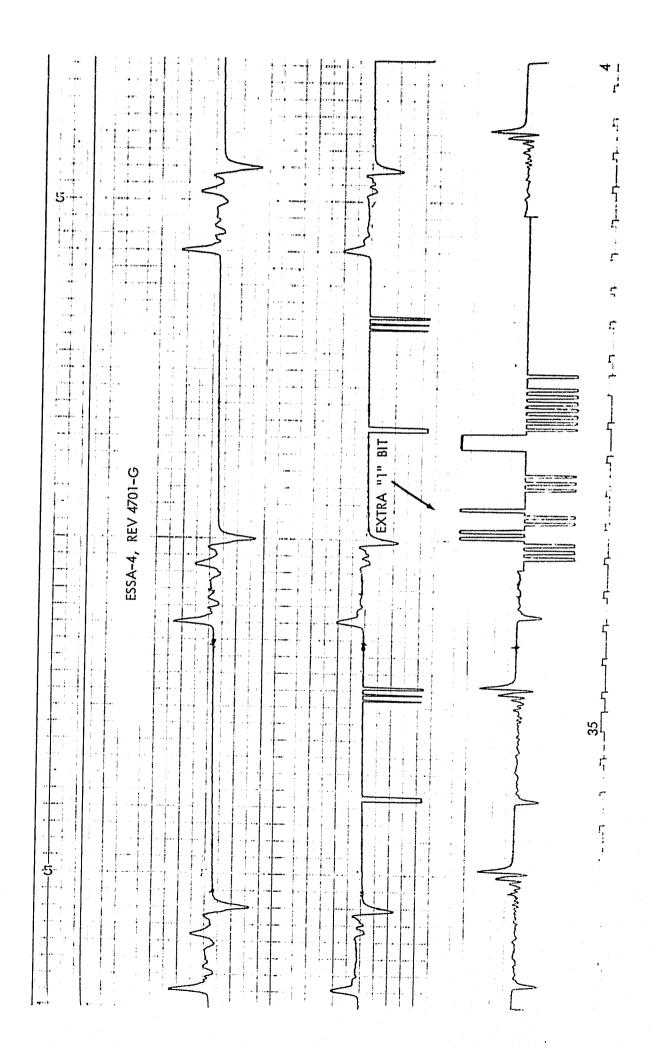
When one station uses tone-pair A and the other station uses tone-pair B, neither station can command the spacecraft or receive a confirm signal back. This test was performed during revolution 4714.

Figure 6. Invalidation of Order by Simultaneous Command

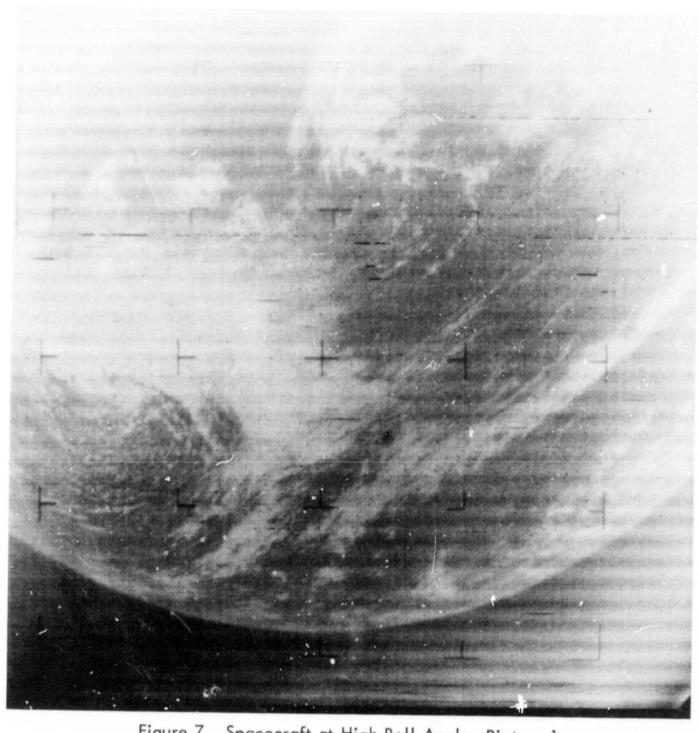
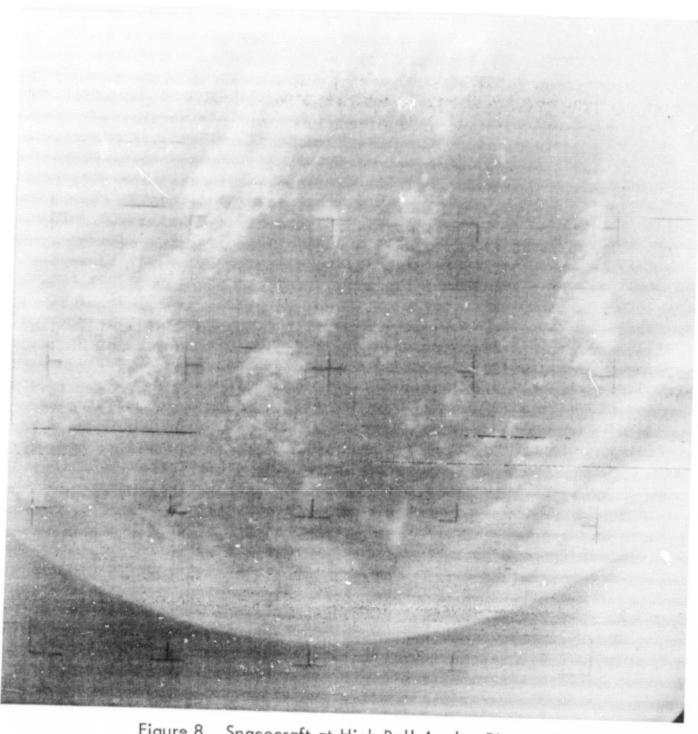
The spin period of the spacecraft was allowed to delay to 5.738 seconds (10.45 rpm) and a picture sequence was commanded. The resulting pictures showed the earth's horizon in the southern half of each picture (as a result of the backup shutter pulse which triggers the camera). Whenever 5.5666 seconds elapse without a horizon-crossing indicator (HCI) pulse, the backup cameratrigger pulse is generated in the spacecraft programmer. The spacecraft had 0.172 second to spin before the camera would look straight down and the HCI field-of-view would intersect the horizon, generating the normal HCI pulse for camera triggering. The 8-channel Brush analog recording showed the backup pulse occurring approximately 0.2 second before the HCI pulse. This was received on revolution 5049-W (Figures 7 and 8).

Figure 7. Spacecraft at High Roll Angle, Picture 1

Figure 8. Spacecraft at High Roll Angle, Picture 2

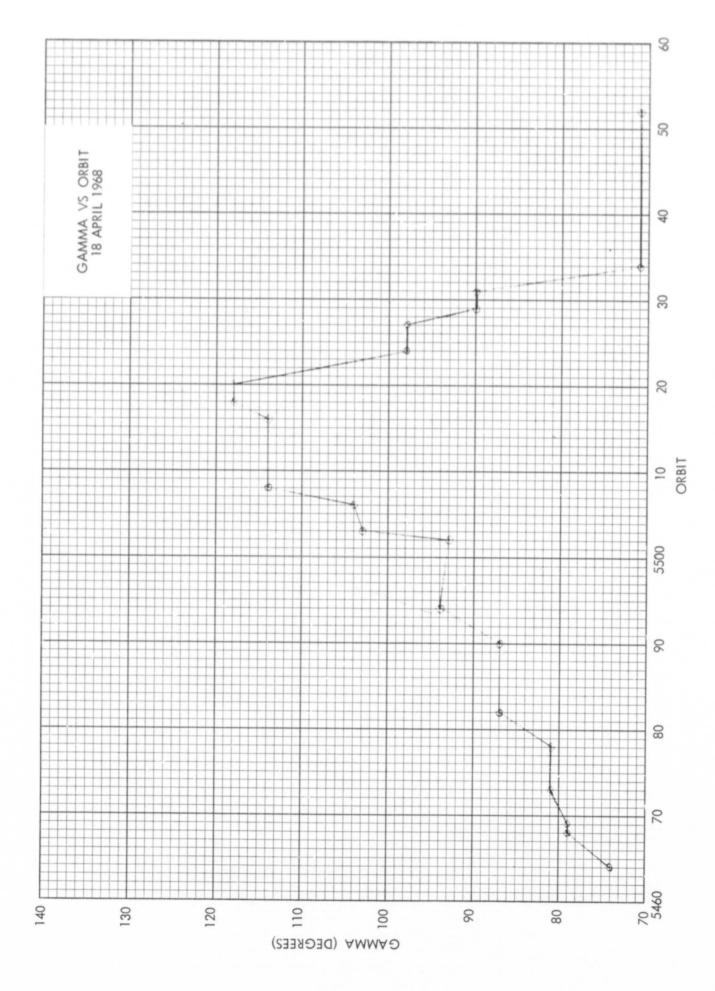
Figure 9. Gamma Angle vs Orbit (5464 - 5552)

Group 3 tests on ESSA 4 took place from April 1 to April 12, 1968, to examine the operation of the spacecraft at extreme gamma angles. Figures 9, 10, and 11 show spacecraft attitude during these tests.

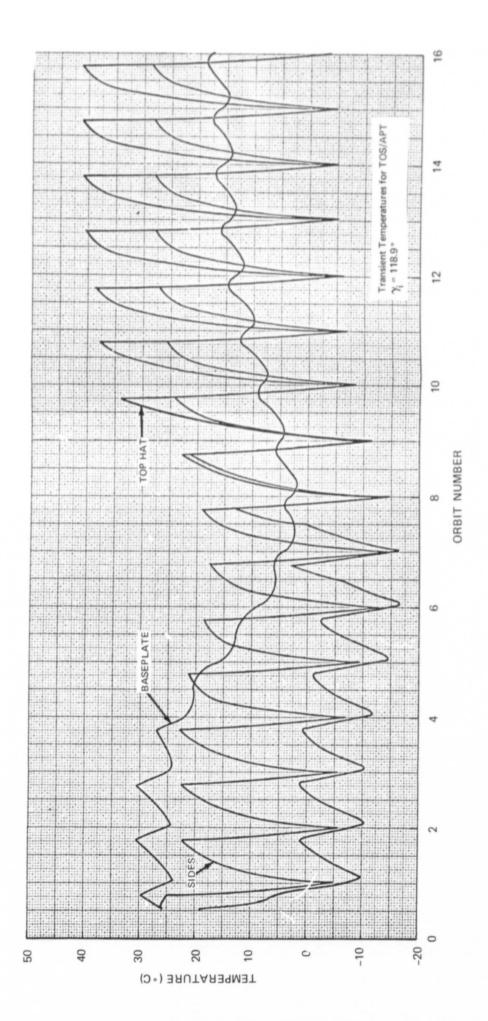
Figure 12. Transient Temperatures for TOS/APT Components

Conflicts of time and available orbits made it possible to look for only gross indications. A spacecraft not in constant sunlight never actually achieves a constant temperature equilibrium on its surface areas (Figure 12). In many instances, temperatures plotted were taken shortly after the spacecraft had just come out of darkness; in other instances, the spacecraft had just completed a series of high-torque QOMAC cycles, with resulting large changes in gamma. Both conditions produce sudden temperature changes. During this group of tests, the amount of sun time was approximately 70 percent.

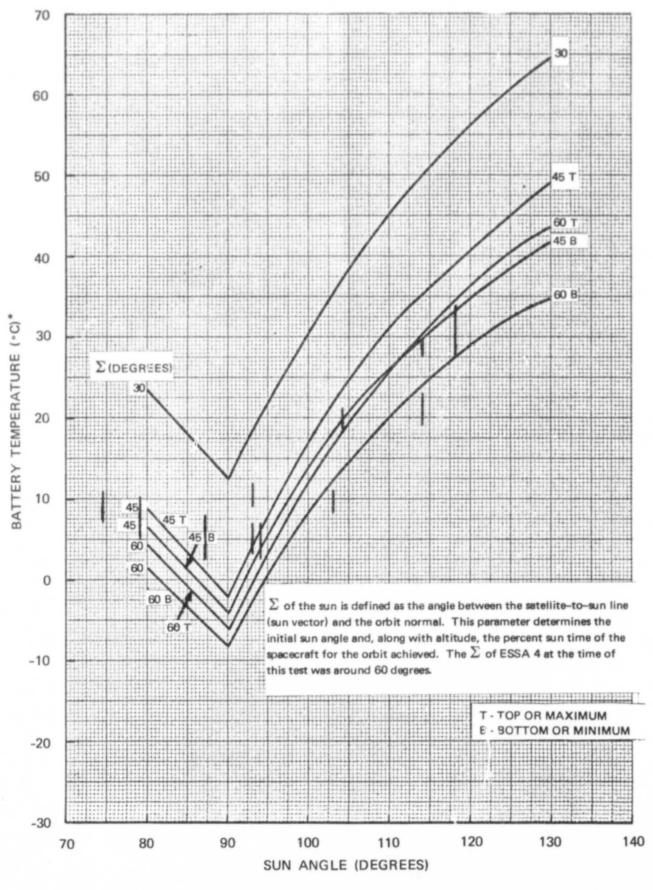
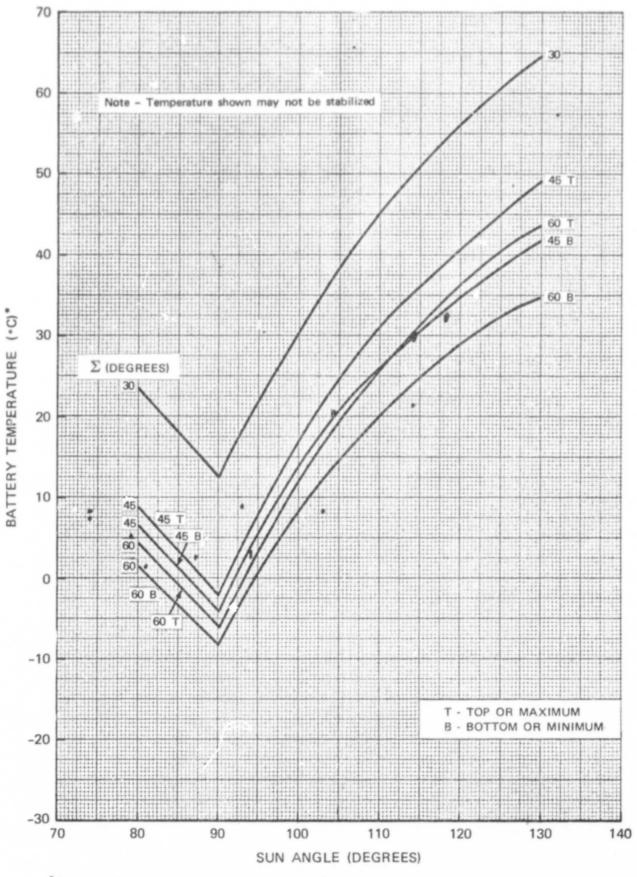
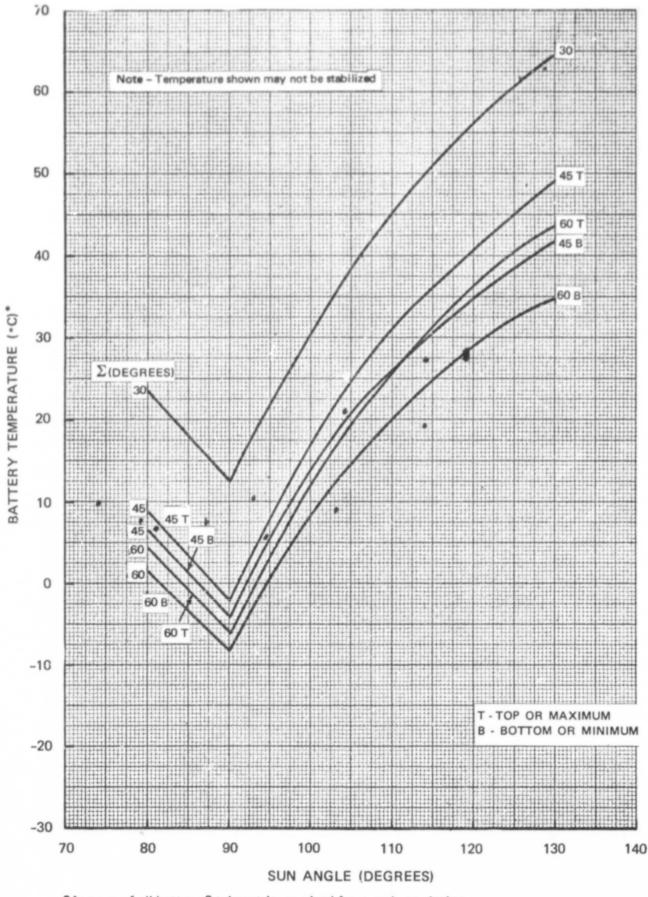
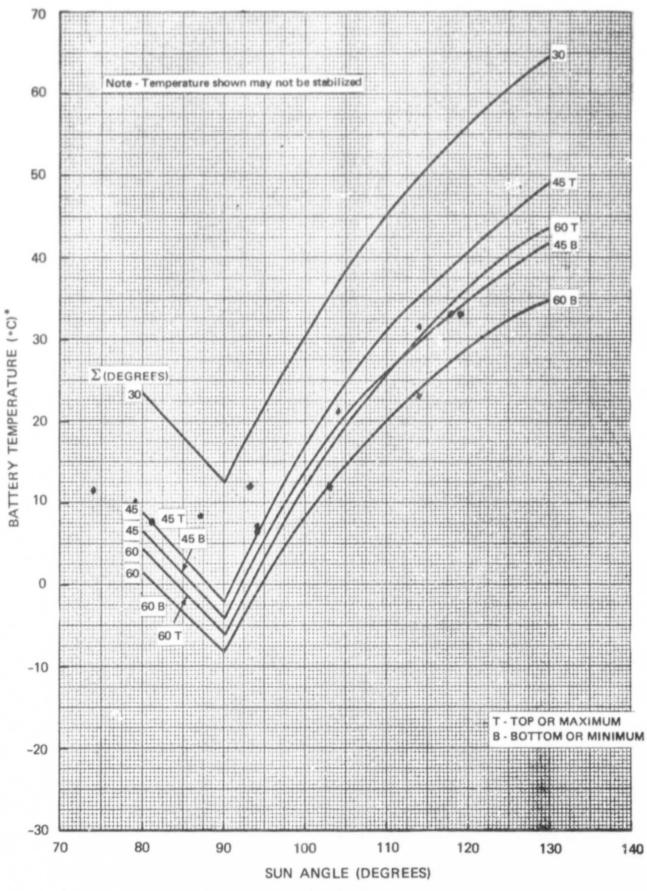
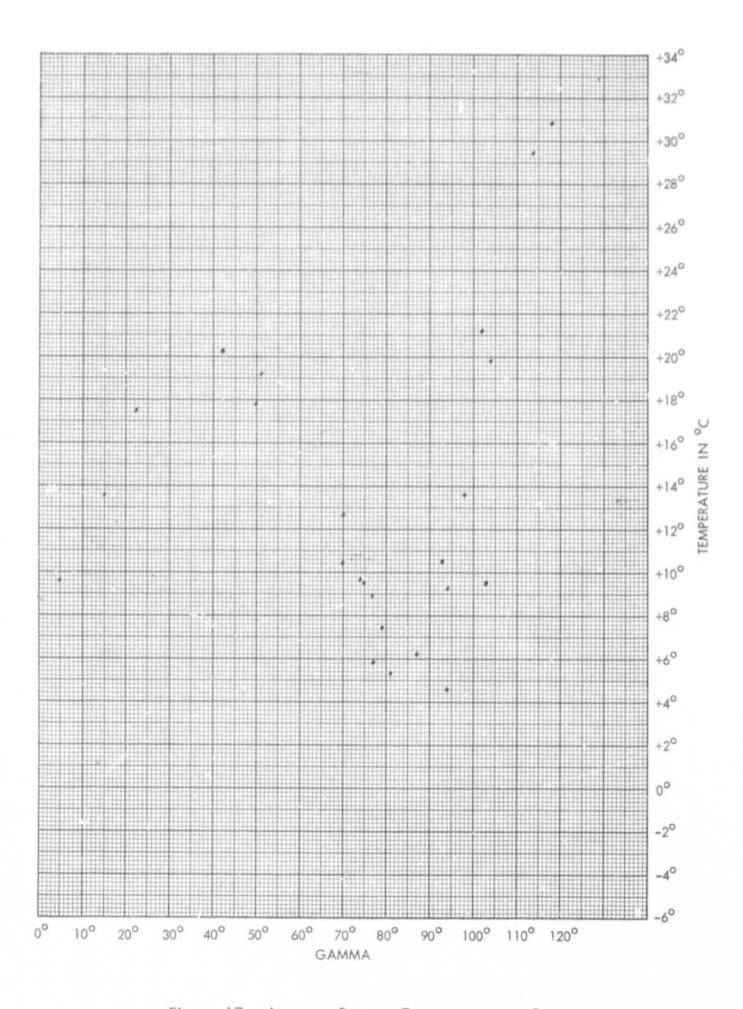
Figures 13 through 17 show the temperature response of the batteries. Actual temperatures observed, plotted with predicted curves in these figures, appear slightly flatter than expected; this is probably the result of little or no stabilization time.

Figure 13. Dynamic Equilibrium and Steady-State Temperatures for TOS/APT Batteries (Average)

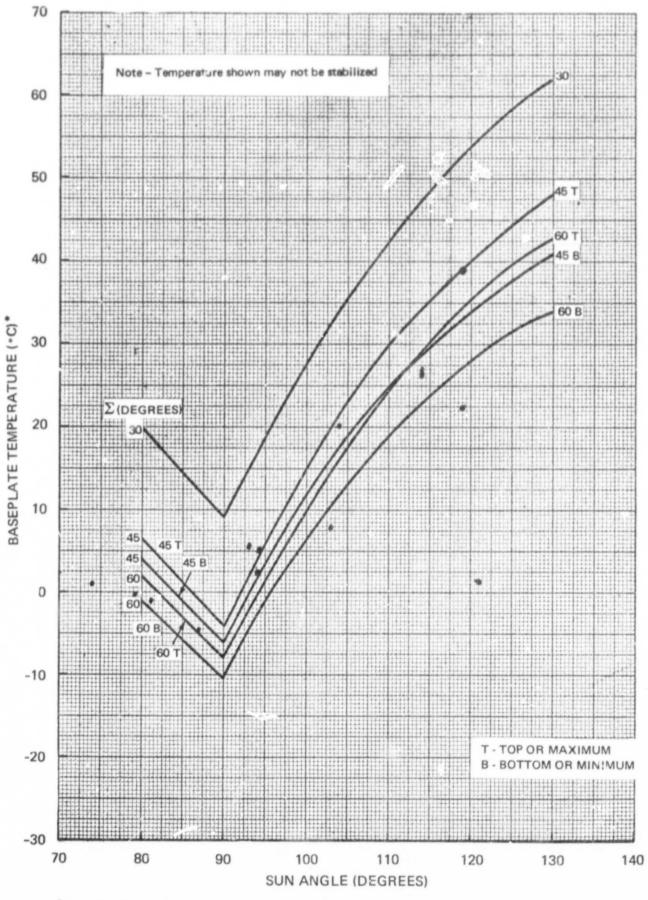
Figure 18. Dynamic Equilibrium and Steady-State Temperatures for TOS/APT Baseplate

Baseplate temperatures (Figures 18 and 19) follow the predicted profile well, certainly within the excursions of Figure 12. This fact supports the theory that the batteries, with their interior position and large mass, would follow closely the predicted temperatures if given time to achieve equilibrium.

These figures, together with Figures 20 and 21, suggest that the temperature minima may occur at a gamma angle of 80 to 83 degrees rather than at the 90 degrees predicted by the mission-mode and thermal-response manual. Considering that the rib structure of the baseplate is external and not normal to the sidewalls, this assumption is probably true. This fact may influence operational considerations for spacecraft that operate in near-high-noon angles (where normal mission-mode orientation of the spacecraft would result in gamma angles around 90 degrees).

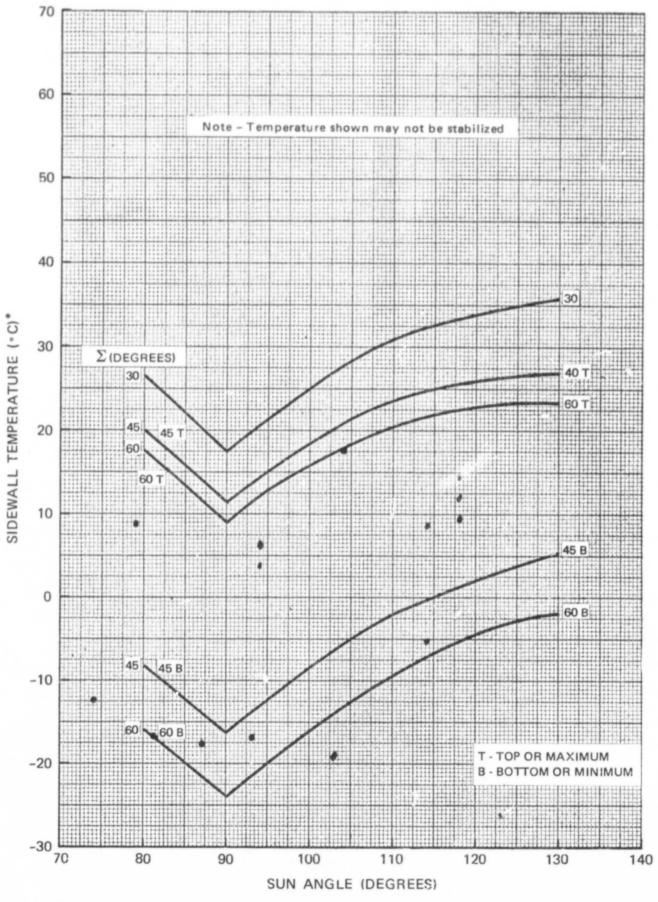
Sidewall temperatures (Figure 20) show the extreme excursions predicted in Figure 12: the magnitudes and slopes of these excusions are too large for meaningful evaluation. Temperatures of the top hat (Figure 21) did not follow the predicted profile nor, apparently, the broad violent excusions of Figure 12, probably because the top hat is in shadow when the spacecraft is at a gamma angle of greater than 90 degrees. In fact, top-hat temperatures dropped well below the telemetry-reduction curves in the calibration book for ESSA 4.

Figure 20. Dynamic Equilibrium and Steady-State Temperatures for TOS/APT Sidewalls

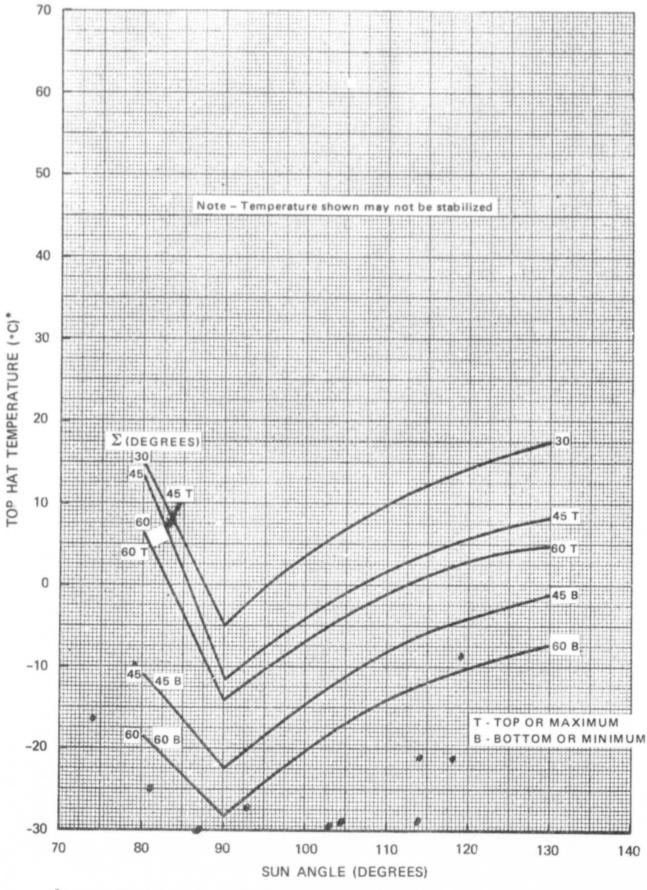
Figure 21. Dynamic Equilibrium and Steady-State Temperatures for TOS/APT Top Hat

Here again, because of the low mass of the structure in question, and the few telemetries available, the plots are not a smooth curve. Measurements obtained suggest that, under these conditions (gamma greater than 90 degrees), the top hat is running far cooler than predicted. Again, these plots suggest that—although the temperature minima may be considerably colder than expected—the stabilized temperature profile might well approximate the shape of the predicted curve more closely than these test plots indicate. In any case, minima for these tests are colder than had been expected.

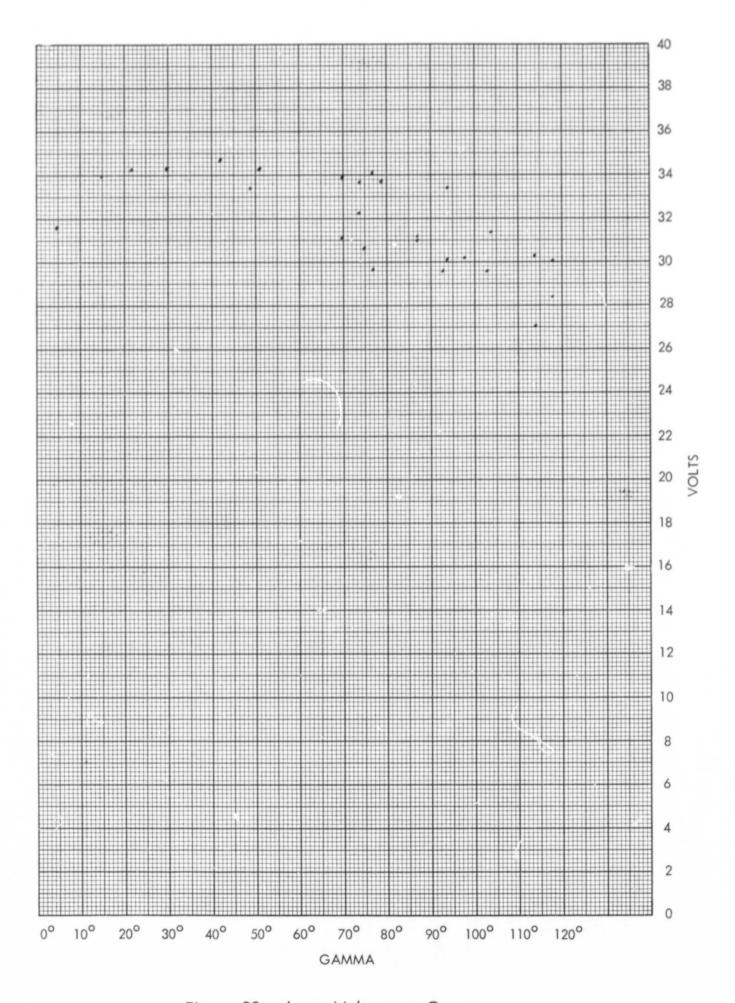
Figure 22. Array Voltage vs Gamma

Figures 22 through 25 show solar-array outputs plotted over a wide range of gamma. Note that these plots show up as two fairly distinct series of points: The lower values (zero) are telemetries taken as the spacecraft emerges from darkness over Gilmore; the higher level plots (+) are taken over Wallops later in the same revolution. The curves are unexpected. More reasonable plots appear in Figure 25, which represents telemetries from four random (over a day or two) 12-picture sequences by ESSA 3. Temperature and/or albedo effect on ESSA 4 may account for the fluctuations shown in the plots; the anomaly is not explainable at present.

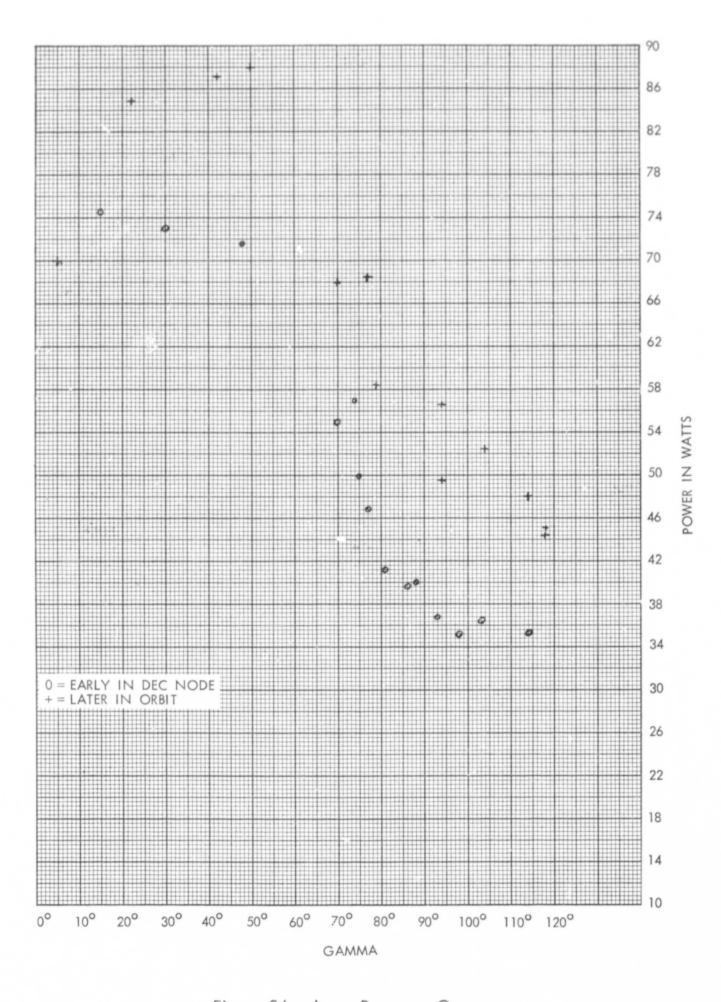
Figure 24. Array Power vs Gamma

Figure 24 shows that the optimum operational mode (from the power stand-point) is around 45-degree gamma. As the power available from a solar cell is essentially a cosine function, loss of efficiency by the sidewalls is compensated for by the increased output of the top hat, resulting in a reasonably constant power available at all gamma angles that are less than 45 degrees.

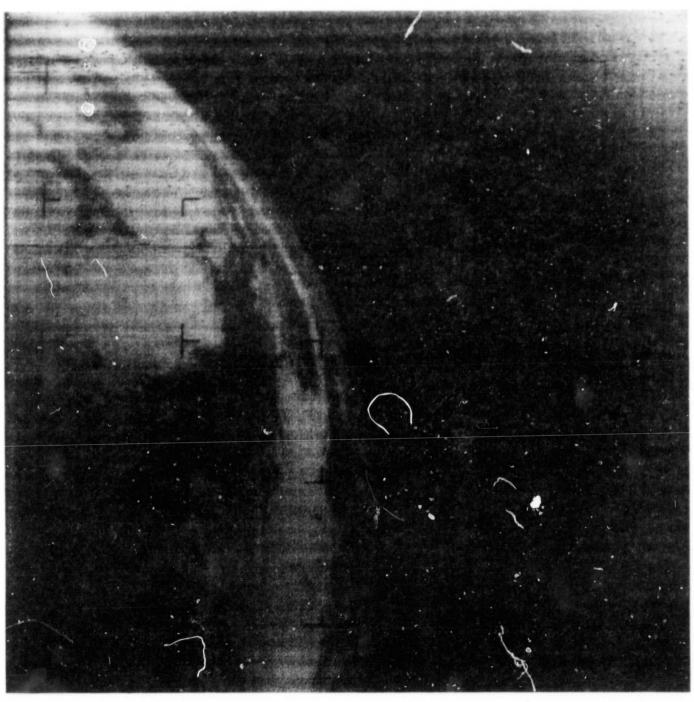
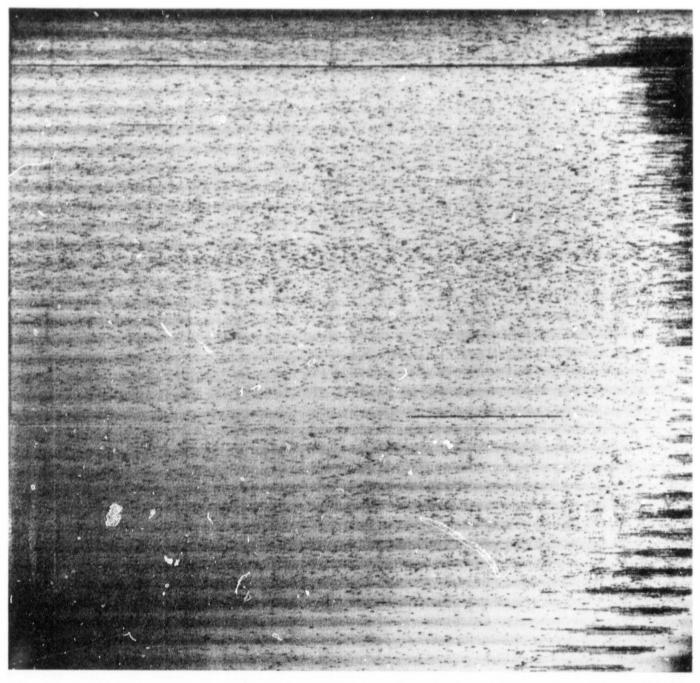
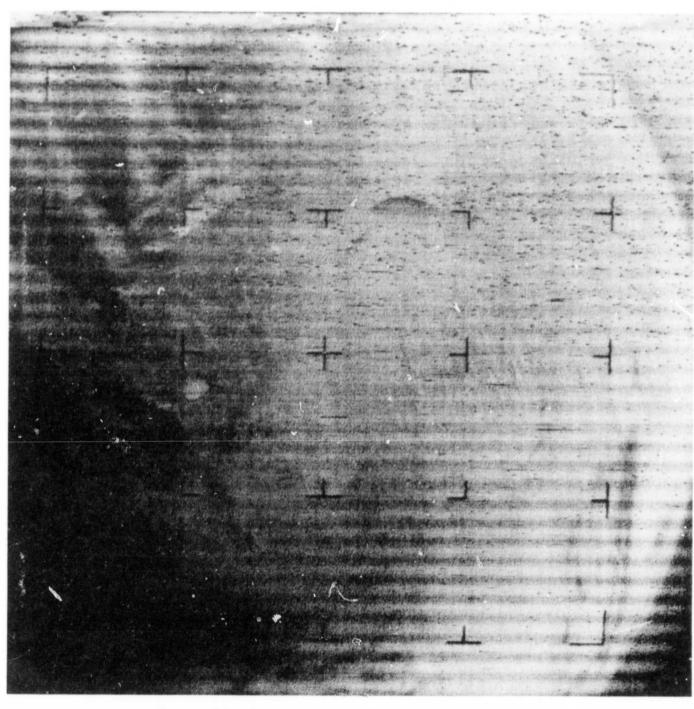
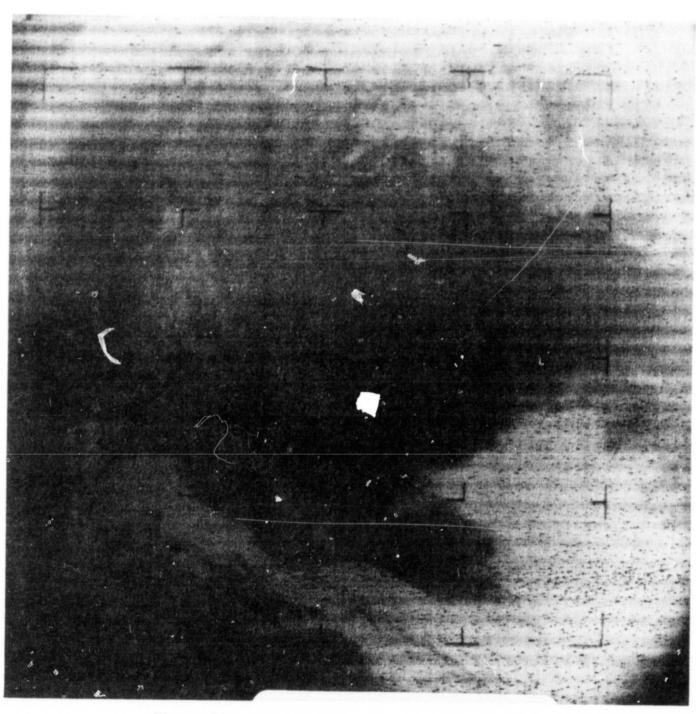
During revolutions 5518 and 5520, a partial picture sequence (Figures 26 through 31) was run for two purposes:

The pictures came out with no observable degradation, and the timing was as close as we could predict without knowing the exact times at which the HCI's lost and reacquired the earth. This procedure finally confirms the operation of a backup system we had not had occasion to use before. The significance of the picture and the spacecraft systems during this particular test may prove to be of operational use: the data suggest that, by using mission mode and a gamma of about 110 degrees, the spacecraft can reach operational temperatures with about 10 degrees less gamma than if the spacecraft had been turned around to obtain gamma of less than 90 degrees. Considering the slow rate of spacecraft orbital drift in relation to the sun, this procedure could put a spacecraft back into mission-mode operation much quicker than turning it around as soon as it reaches a high-noon position (spacecraft in line between the sun and the earth; i.e., local apparent noon).

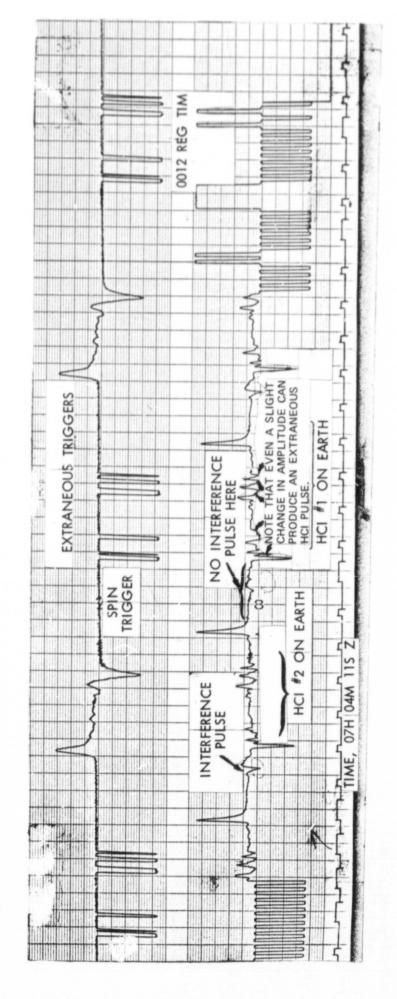
Figure 32. Chart 1, Revolution 5743-G

MASC polarity switching under full load was the nearest to a problem that was encountered: Actual changing back and forth in MASC polarity occurred with no sign of any problem to the spacecraft, but on revolution 5743-G we observed an anomaly in the MASC trigger. Instead of the normal 50-percent-on/50-percent-off telemetry indication, we observed a 70-percent-on/30-percent-off indication varying throughout the pass (reversed 30-percent/70-percent in negative MASC). Examination of the SCO-3 telemetry recording showed that the cause was apparently sun interference on one HCI sensor, showing up after the earth/sky transition of the opposite HCI sensor. This pulse occurring during "sky time" caused a false MASC spin trigger. Gamma at this time was 77 percent (DSAI readout is either 77 or 80 degrees, as bit two is always zero). Figures 32 through 39 are excerpts from an 8-channel Brush recording from revolution 5743-G; this series of charts shows MASC switching while the space-craft is mistriggered by a pulse which shows up in the HCI lines.

Chart 1: start of 5743G; spacecraft in ascending node. Note sun interference appearing on one HCI sensor and not on the other; examination of this and the following recordings suggest that HCI is seeing the sun, but that HCI 2 is not. Note fast change in sun-pulse relative position throughout this pass, as shown in the following charts.

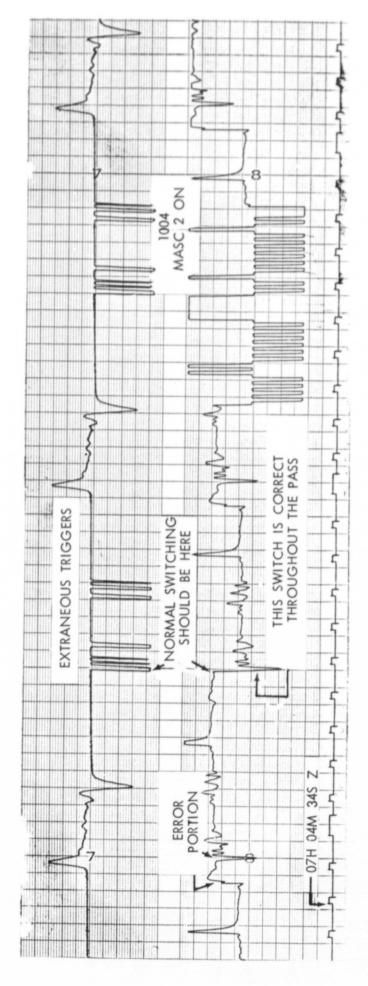
Figure 33. Chart 2, Revolution 5743-G

Chart 2: start of a MASC-POS sequence. Note early switching as compared with the previous chart. Observe how small a signal is needed to generate a false or extraneous spin trigger.

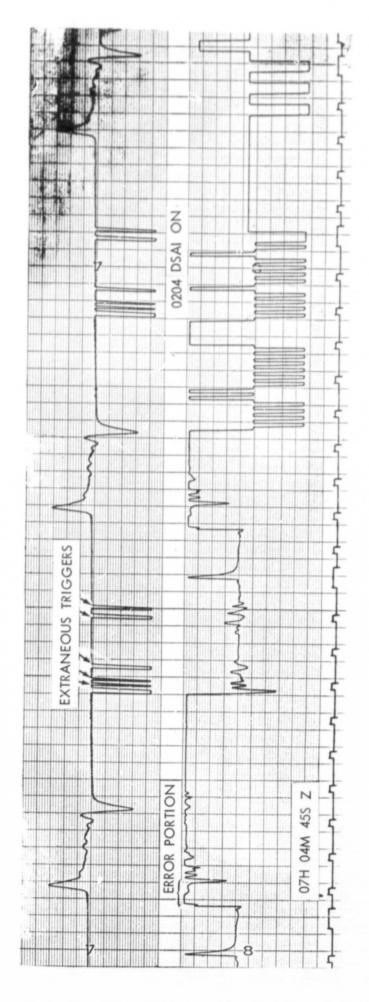
Figure 34. Chart 3, Revolution 5743-G

Chart 3: continuation of chart 2, spacecraft now in a double MASC-POS cycle. Note timing of early switching of MASC cycle in relation to spin-trigger pulse and the SCO 2 trace above it (AHI 2). Followed through this series of charts, this timing will be seen to change quite rapidly.

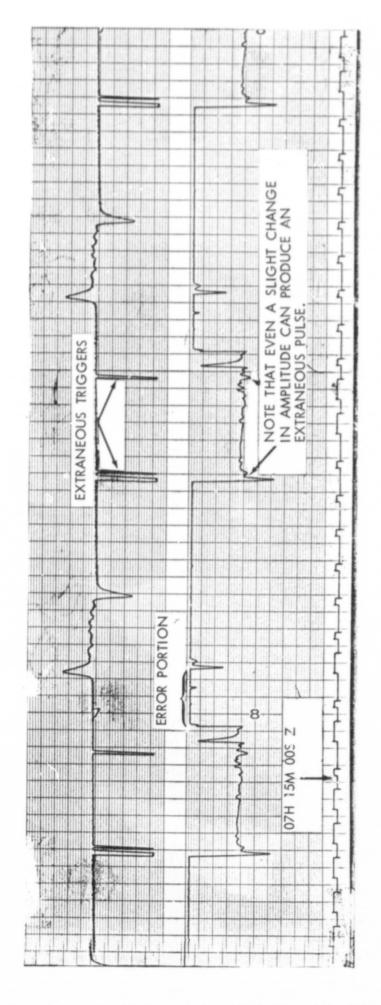
Figure 35. Chart 4, Revolution 5743-G

Chart 4: near end of first MASC-POS spinup and later in time than chart 3. Note how timing has changed: switching is now off by 35 percent on each switching cycle; spacecraft at this point, instead of having a 50/50 ON-OFF cycle, has a 65/35 cycle and, as a result, is only 65 percent effective.

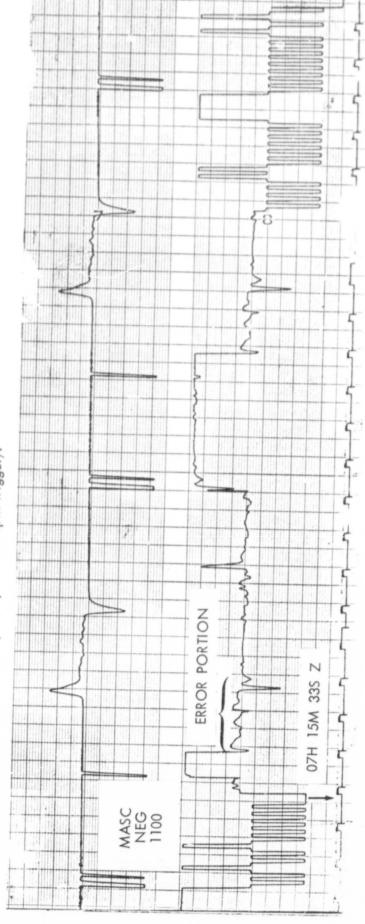
Figure 36. Chart 5, Revolution 5743-G

Chart 5: showing switch of MASC polarity in the middle of a cycle. Note that the cycle, still 65%/35%, is reversed in phase (compare cycle with spin trigger).

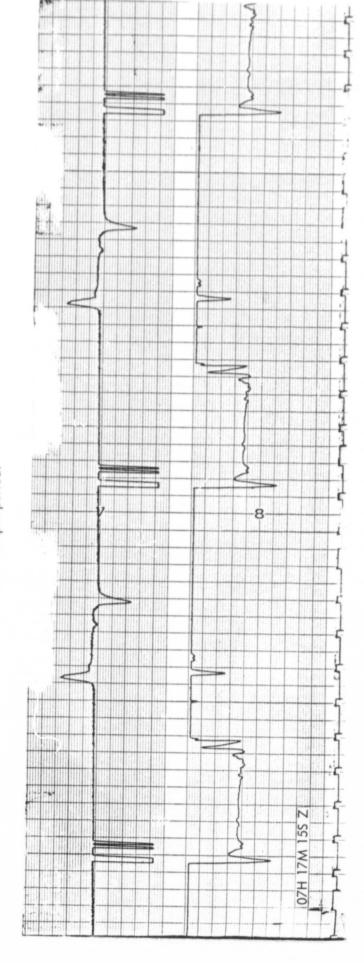
Figure 38. Chart 7, Revolution 5743-G

Chart 7: slightly later than chart 6, this is the final trim of the spin period.

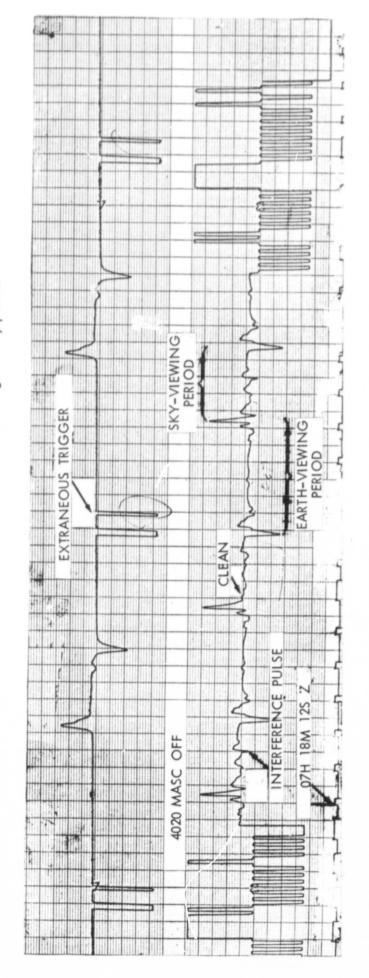
Figure 39. Chart 8, Revolution 5743-G

Chart 8: MASC OFF; compare with chart I and note how the interference has moved through the sky period.
